Clarification Upsets and Ion Exchange Resin Symptoms Due to Design

*Patrick L. Coterillo, Process Engineer, ASR Group Domino Sugar Refinery,
Baltimore, MD*

Summary

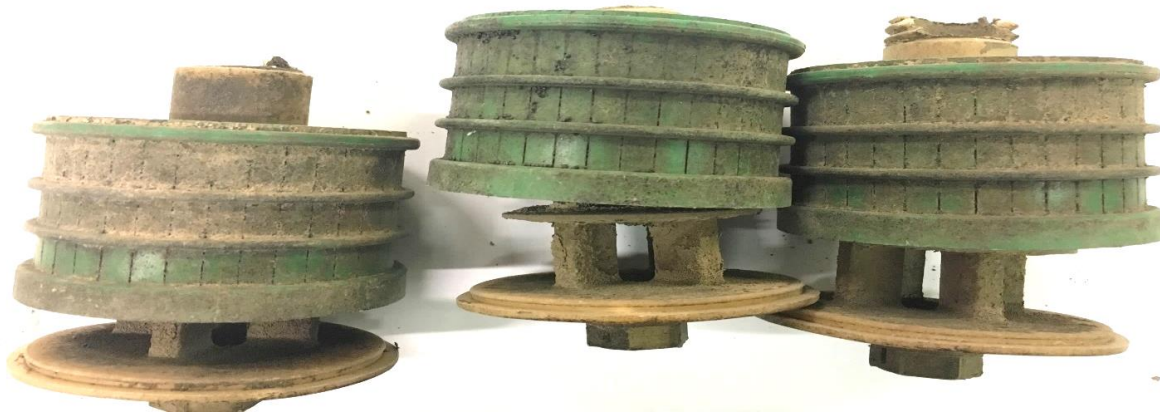
Figure 2: Examples of CaCO₃ Build Up on Nozzles

When one single nozzle breaks it leads to a total IER column shutdown reducing the refinery throughout by approximately one-third of its total capacity. These nozzle breakages can also lead to resin beds with different ages mixing thus having aged resin inside of a fresh bed if a middle plate nozzle breaks.

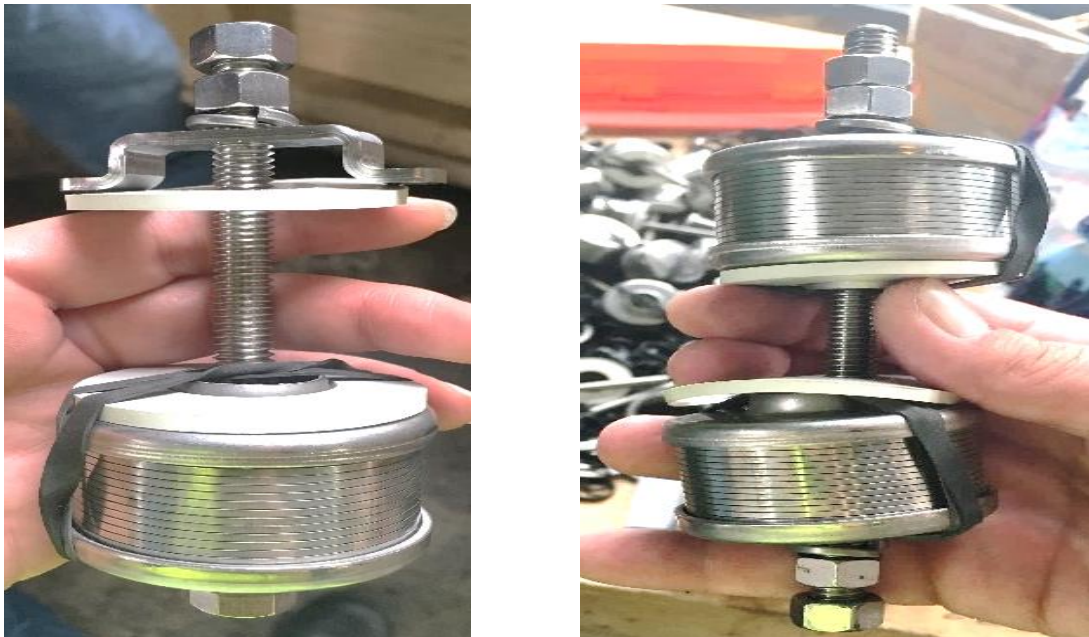
Figure 5: Stainless-Steel Nozzle Design – Top Nozzle (left), and Middle and Bottom Nozzle (right)

As a viable replacement for the fiberglass nozzles, all nozzles in the columns were replaced with stainless steel wedge wire nozzles. Without changing the nozzles, the estimated maintenance and downtime costs were projected to reach approximately \$1,000,000 over the course of 10 years. However, the nozzle upgrade was not cheap with the initial upfront cost of purchase and installation of \$480,000. There are several pros with the stainless-steel nozzles design. One is their increased mechanical durability in real-world process conditions. Since the installation of the stainless-steel nozzles in 2019, there have been no instances of a nozzle breakage. Another benefit is the time allotted to maintenance. Stainless Steel nozzles have shown to require less maintenance than their fiberglass counterparts. Additional refineries in ASR Group have had stainless steel nozzles applications for upwards of 10 years with no signs of damage or corrosion. Compared to a 2.3-5-year life span for the fiberglass nozzles the longevity proves to be a big advantage.

These stainless steel nozzles though more robust, provide several drawbacks. The nozzles on both the bottom plate and middle plate are composed of a dual wedge wire assembly comprised of 4 gaskets and just a single 3/8th inch all-thread to hold the assembly together. The installation of this assembly across the column proved to be sensitive to accurate installation, if the nozzles are not installed perfectly straight, it could lead to premature failure and resin loss.

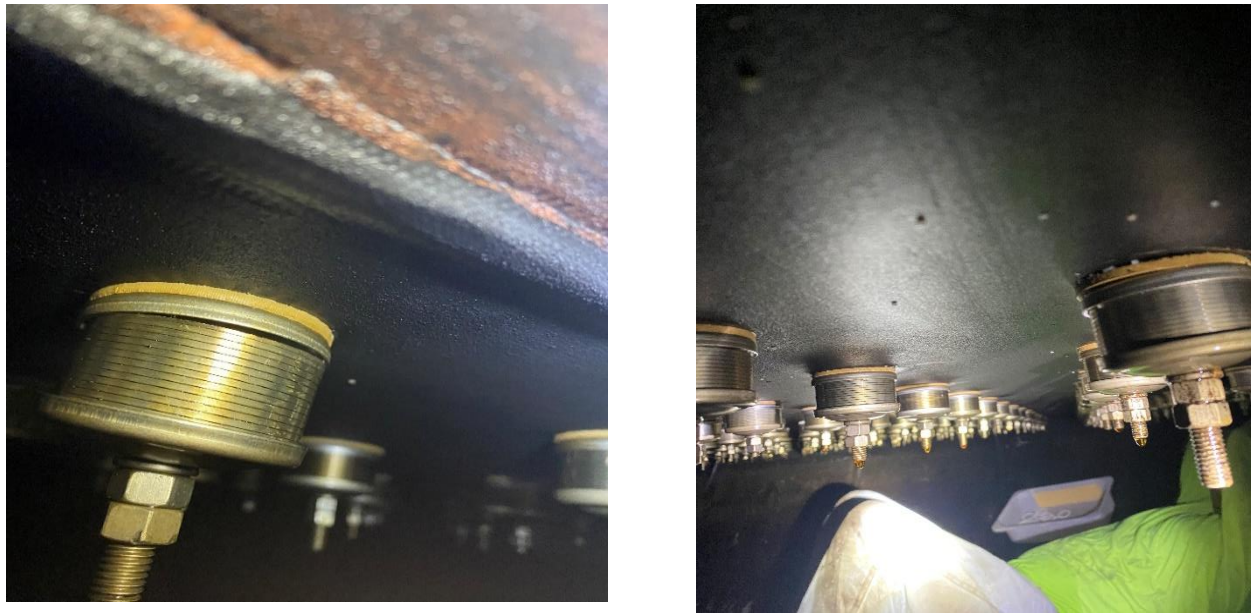
Figure 6: Examples of Misaligned Nozzles

As can be seen from the above photographs, misaligned nozzles can result when the nozzles are not placed flush against the securing plate. These misaligned nozzles, depending on the severity, can lead to ion exchange resin leakage out of the column. As mentioned previously, resin leakage can cause premature shutdown of a column reducing throughput. To address this risk procedures have been updated to include a post nozzle install inspection procedure where team members inspect all the nozzles for alignment. Additionally, a torque setting was specified for each nozzle to avoid under or over torquing. Mechanical modifications were made to the top plate nozzles to address the situation where there were only two points of contact between the metal bracket, we call the 'T-Bar', and the gaskets. These two points of contact became compromised over a 3-year span which led to increased susceptibility to nozzle misalignment. To compensate for this a modification was made to the install to add a more even distribution of pressure throughout each nozzle. The pictures below show the progression of this top nozzle continuous improvement install.

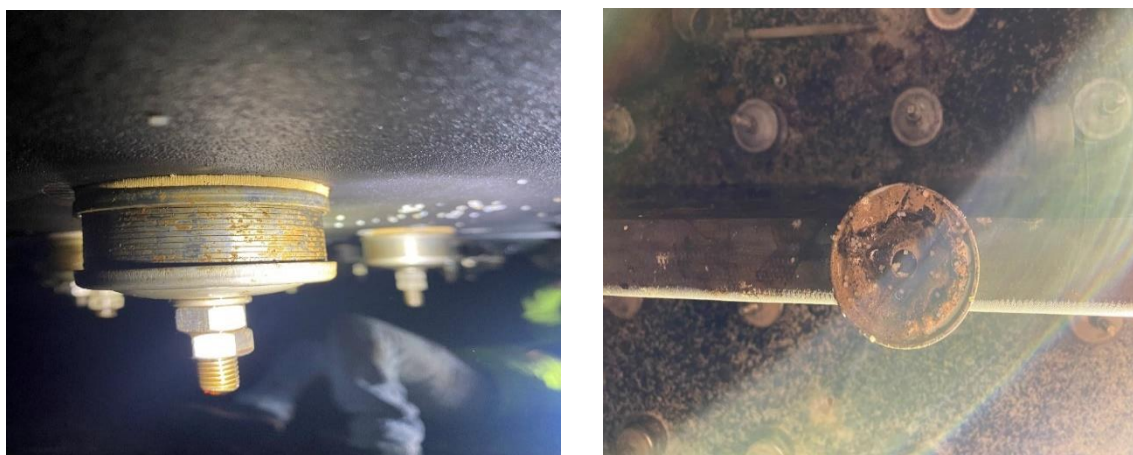
Figure 8: Nozzle Buildup – External (left) and Internal (right)

As mentioned previously with the nozzle install, one of the big challenges faced is how to deal with the presence of calcium carbonate from the clarification/filtration process in the Decolorization feed stream. Issues in the filtration step will lead the passing calcium carbonate causing blockages in the tight spaces in the nozzles and can be very difficult to eliminate. The pictures below show the level of buildup present on and inside of the stainless-steel nozzles.

This build-up came with a detrimental effect of a severely reduced throughput. As a result of this builds up the throughput from ion exchange was reduced at times to 25% of the target flow rate of the Decolorization column. Clearing out the blockages is challenging and requires a significant financial and personnel resources. While Baltimore team tried to clean the nozzles by dissolving the calcium carbonate with an in-situ acid treatment, resulting in some throughput improvement the most impactful action was the replacement of all the distribution nozzles resulting in multiple days of downtime.

Now that the issue has been corrected several different measures are ongoing to reduce the amount of calcium carbonate carryover from the filtration process. At the Baltimore facility there are plans to install an online turbidity meter. This will be used to quickly address any filtration upset and prevent build up in the IER column nozzles rather than allow the build-up to accumulate. At present turbidity measurements are completed several times per shift in the lab. Also, the clarification process is under tighter pH control with regular checking of the accuracy of the instruments on the carbonation reactors to reduce the risk of generating small calcium carbonate flocs. Some of our sister ASR plants have multimedia filters upstream of the Decolorization process, which help prevent residual calcium carbonate from entering the columns. Currently the Baltimore refinery has a filter bag upstream of the columns which does help with capturing the passing calcium carbonate from filtration, but there is room for improvement in terms of the size of the bag filter. A smaller mesh will result in more calcium carbonate captured, but more frequent bag filters to be changed out.

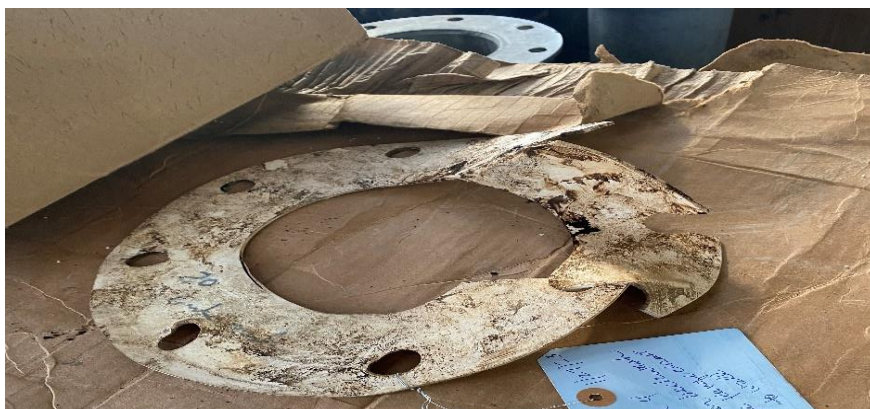
Figure 11 Damaged Internal Gasket

Through incorrect installation, this gasket was damaged heavily which led to significant amounts of resin loss during the IER column backwash. To prevent resin loss, the backwash step was skipped while the repair was planned and executed, but that took several weeks to execute. As a result of that suspended solids were not removed during this time and there was a large amount of resin loss through the backwash piping.

When exploring new materials for the gaskets, Gylon gaskets were an effective alternative. Not only are they made of food grade material, but they are much more durable when it comes to the ion exchange resin application. Since installation, several months ago there is no evidence of a gasket failure during a backwash.
